# NATIONAL BUREAU OF STANDARDS REPORT

9642

Howell-Bunger Valve No. 1  
Summersville Dam, Gauley River,  
West Virginia

T. R. Shives  
Engineering Metallurgy Section  
Metallurgy Division

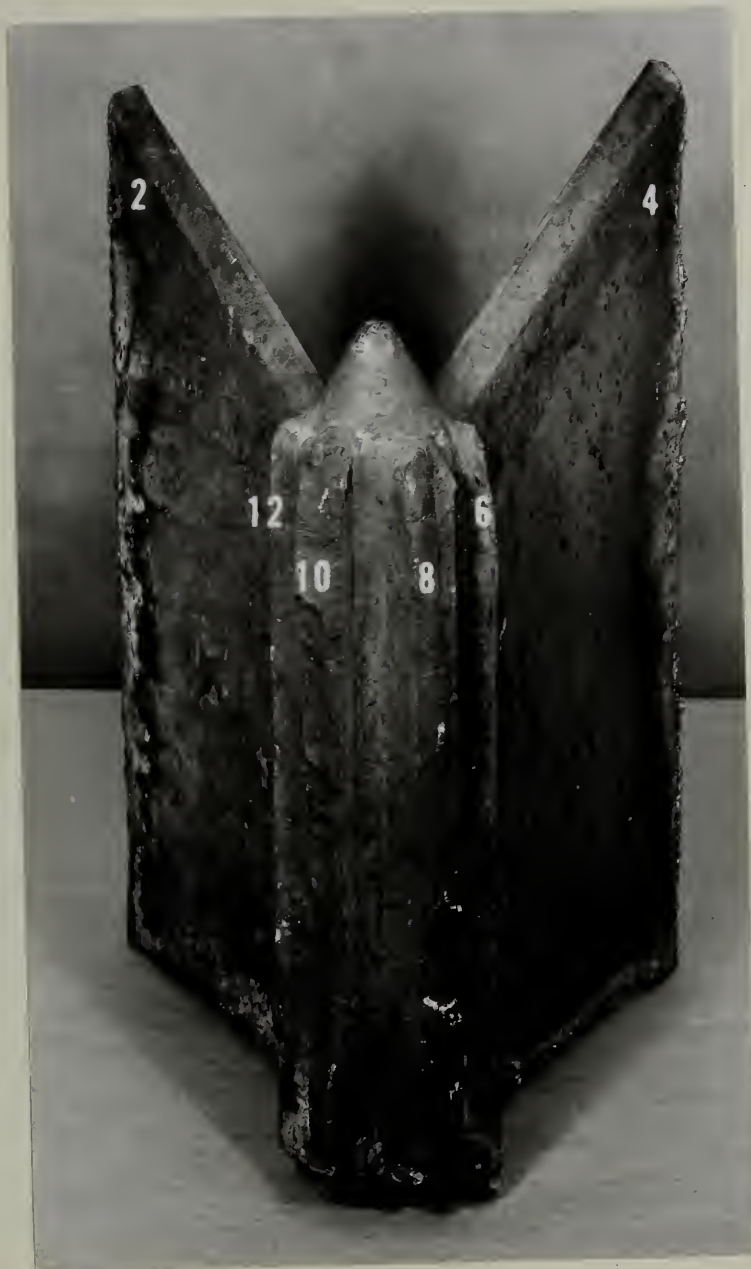
A portion of the upstream end of the valve consisting of part of the hub (approximately 18 inches in length) and parts of both remaining vanes was designated to be cut out and shipped to NBS for examination (figure 1).

Figure 1. Portion of Howell-Bunger Valve No. 1 as received at NBS. Vane numbers are shown. X 1/4

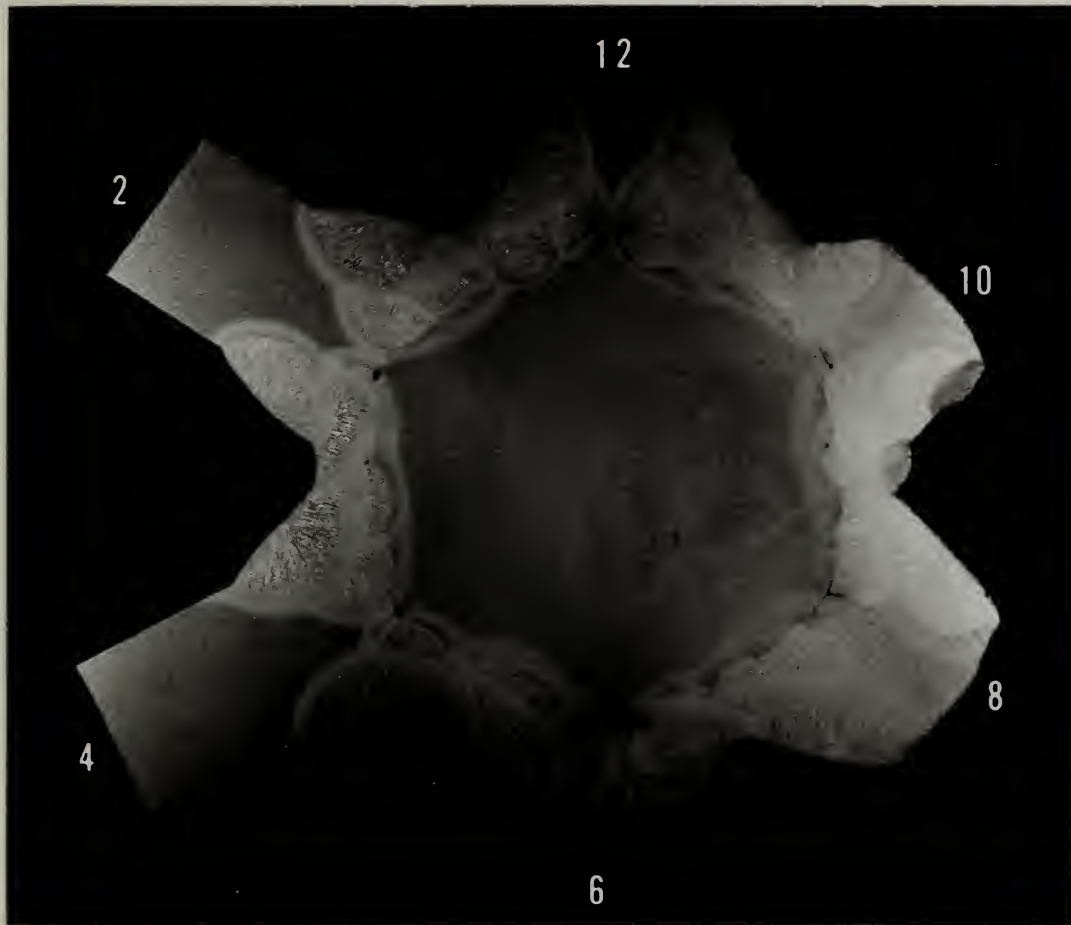
A transverse slice through the hub and parts of each vane about 12 inches from the upstream end of the valve is shown in figure 2. This section has been etched to show the configuration of the weld material and heat affected zones in relation to the hub and vanes. Most of vanes 2 and 4 have been cut off. Each of the fractures began in the region where the weld material meets the heat affected zone of the vane.

It is to be noted from figure 2 that there are somewhat sharp re-entrant angles at the junction between weld material and the heat affected zone in the segments of the two vanes which had not failed. These re-entrant angles act as notches or stress concentrators which are very undesirable and can be quite detrimental. The crack in vane 4 occurred at such a place, and while it is difficult to establish the severity of the angle between the weld and vane for the four fractured vanes, the fractures occurred in the regions of these angles. It is quite likely that the same undesirable re-entrant angles existed for these vanes also.

Figure 2. Transverse slice through hub and part of each vane. Vane numbers are shown. 5% Nital etch. X 3/4

This condition can be corrected by grinding these angles to provide a smooth transition from the weld to the vane. The failure would definitely be postponed by the elimination of these re-entrant angles, but there is no assurance, however, that eventual failure in these areas would not occur. The cyclic stresses are quite high, as mentioned earlier, and this investigator is not aware of any valve assembly in operation with the re-entrant angles ground smooth so that a comparison can be made.

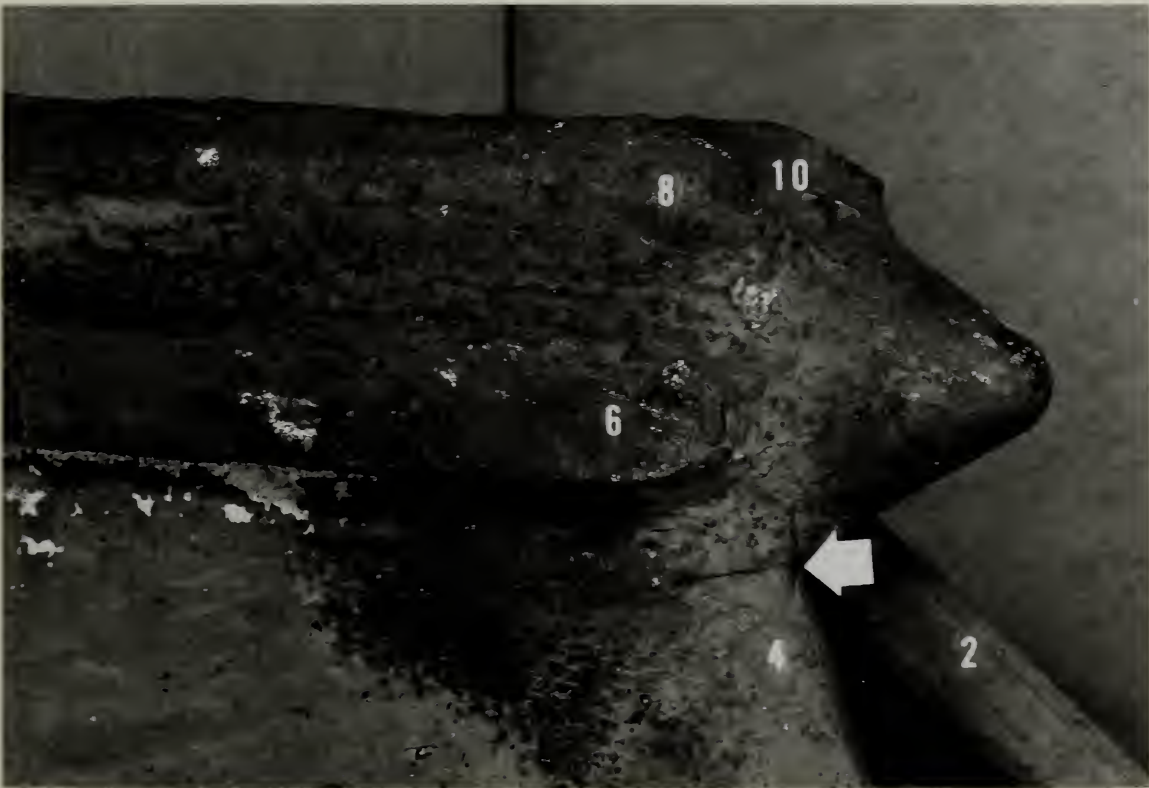
In addition to the four fractured vanes, a crack about five inches long was found in the upstream end of vane 4 in the same relative location as the other fractures (figure 3). The crack was opened and the exposed fracture surface is shown in figures 4 and 5. The fracture consists of two series of cracks, each of which has many sources, which propagated in fatigue. One series originated on either side of the vane and propagated transversely (in figures 4 and 5, one series propagated upward and one downward) toward the center of the vane. The junction of the two series is characterized by the longitudinal ridge near the fracture center.

Figure 3. Upstream portion of Howell-Bunger Valve No. 1 showing crack in vane 4. Vane numbers are shown. X 1/2

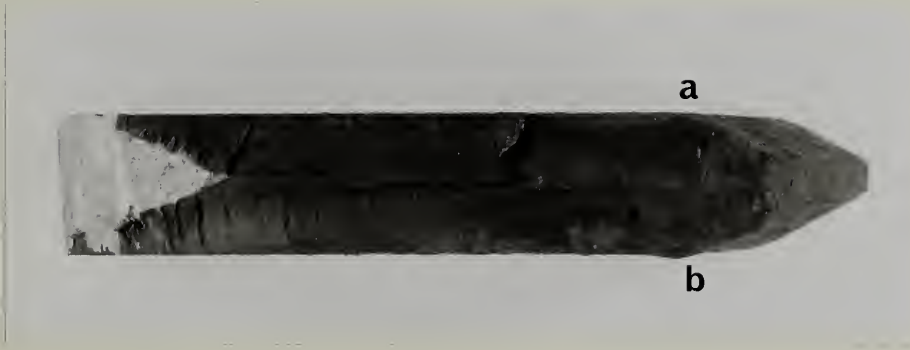
The exact starting points of the cracks could not be determined from the fracture surface, but the most probable locations are at "a" and "b" (figure 4) because the cyclic stress due to bending of the vane would have been greatest there.

On some of the transverse ridges, striations are visible (not clearly evident in the photographs). The spacing of these striations indicates that the fatigue cracks were probably propagating at a fairly high rate, which in turn indicates that the cyclic stress was much higher than the fatigue limit of this material.

Figure 4. Fracture surface of vane 4. Upstream end is at right. X 3/4

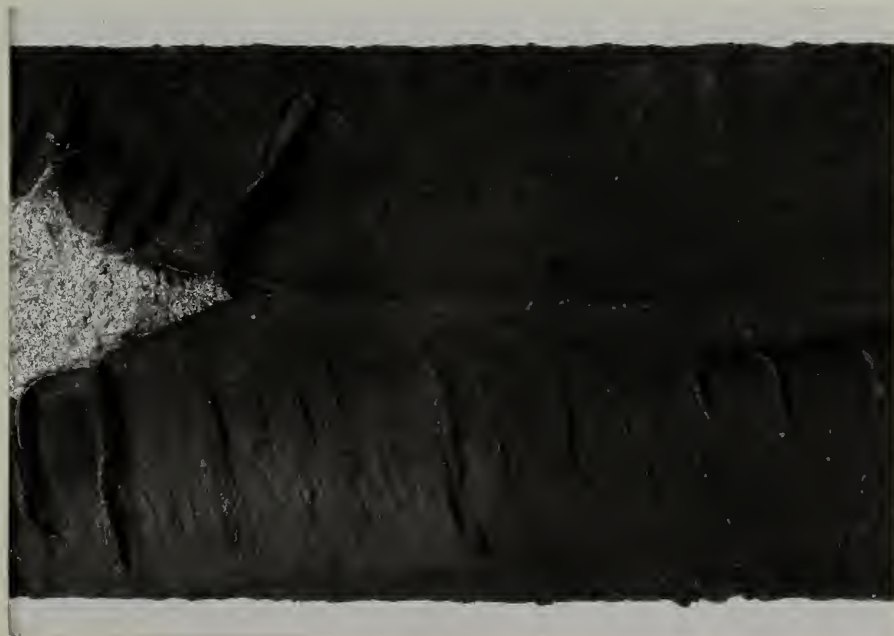
Figure 5. Fracture surface of vane 4. Upstream end is beyond right side of picture. X 3

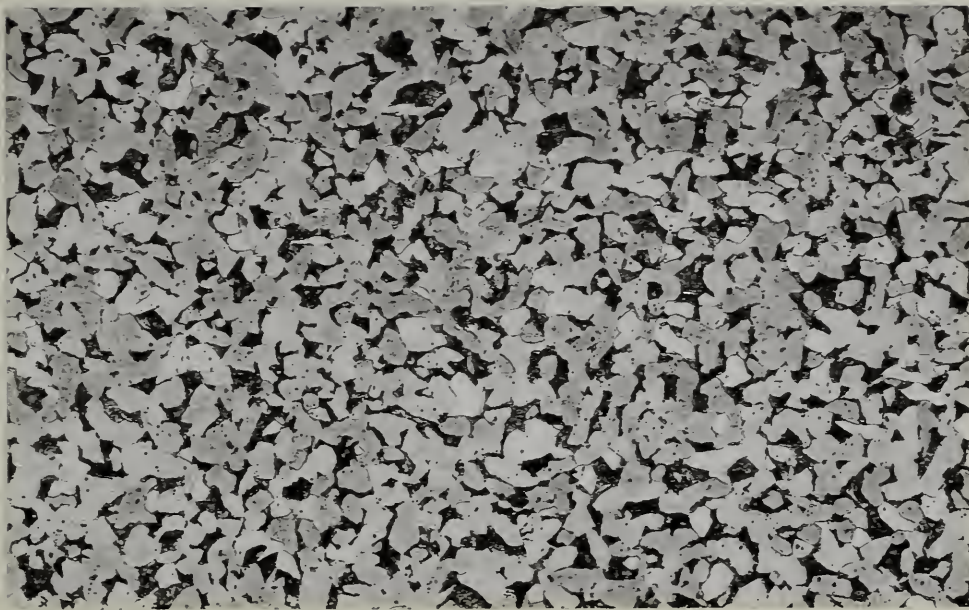
The microstructure of the hub (figure 6) consists primarily of ferrite and pearlite with a reasonably fine grain size. This structure is considered to be satisfactory.

Figure 6. Microstructure of hub. 1% Nital etch.  
X 100

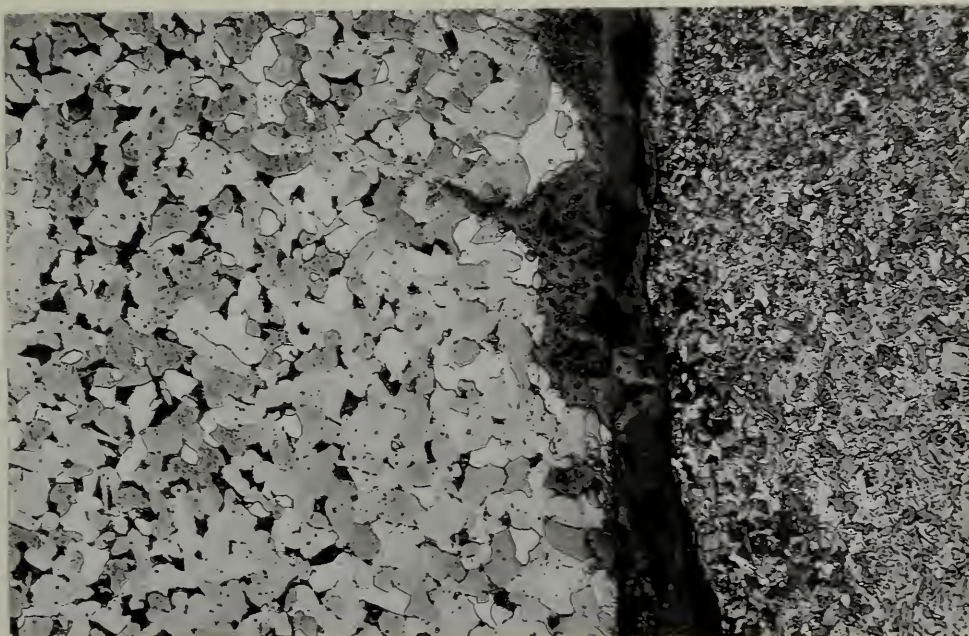
In some areas between the hub and the vanes where there is a lack of welding (figure 2), the surface of the hub exhibits some decarburization (figure 7) which would tend to weaken the material, but this has not contributed to the failure.

Figure 7. From left to right: hub microstructure,  
area of lack of welding, and heat  
affected zone of vane. Note decar-  
burization near surface of hub. 1%  
Nital etch. X 100

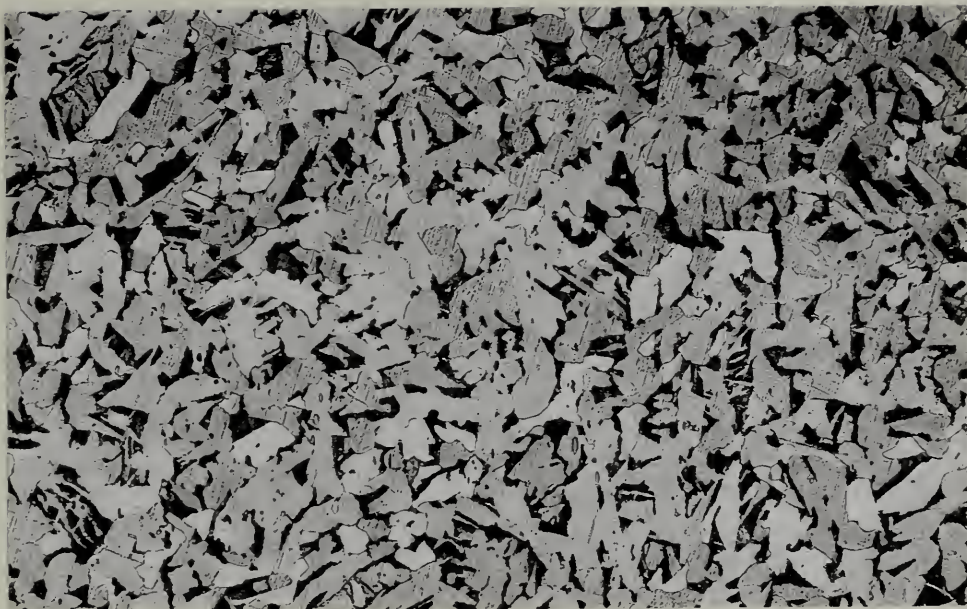
Vane 4, which had partially fractured, exhibits some evidence of an undesirable Widmannstätten structure (figure 8). The microstructure of fractured vane 6 (figure 9) is coarse and exhibits a Widmannstätten structure to a greater degree. Prior austenite grains are visible. The structure of vane 6 is poorer than that of vane 4, but both structures indicate too high a rolling temperature for the steel.

Figure 8. Microstructure of vane 4. 1% Nital etch.  
X 100

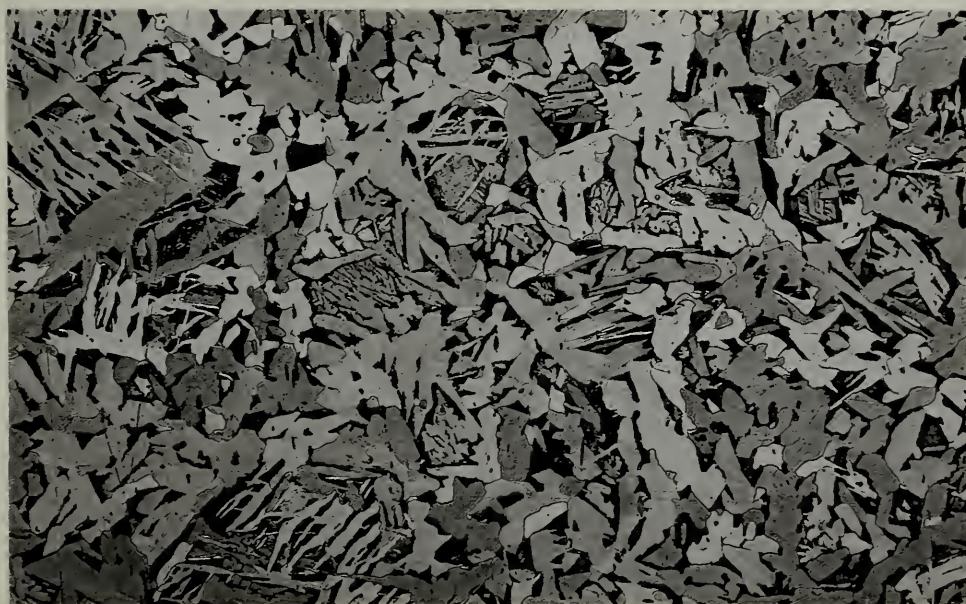
Figure 9. Microstructure of vane 6. 1% Nital etch.  
X 100

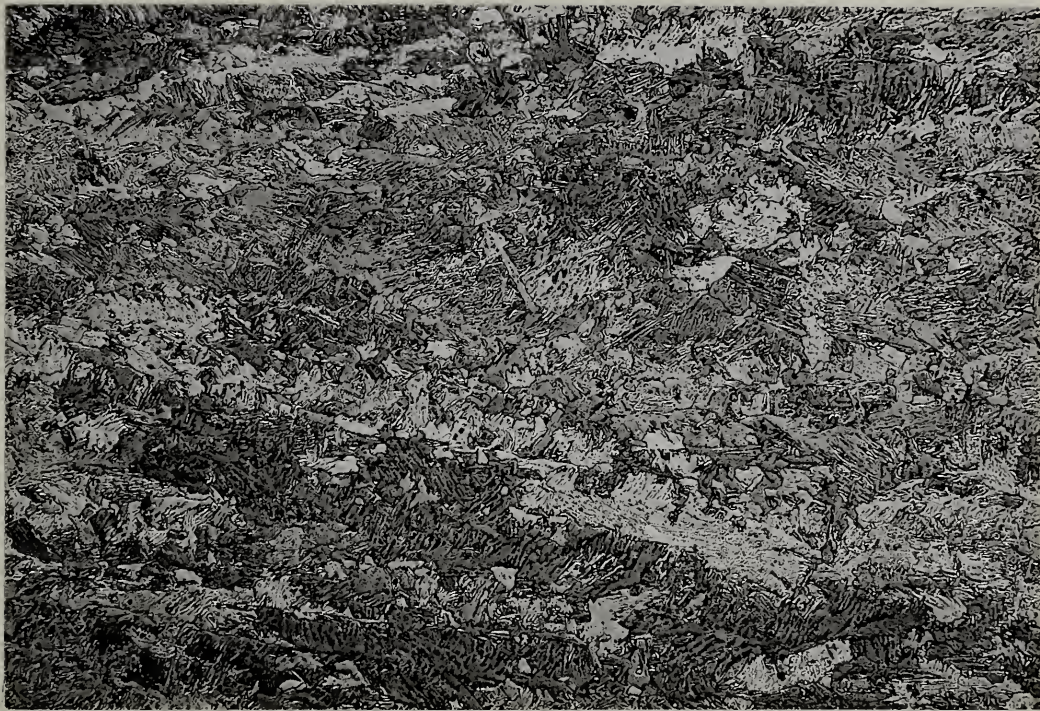
The microstructures of the weld material and the associated heat affected zones (figures 10 and 11) are satisfactory.

Figure 10. Microstructure of weld material. 1% Nital etch. X 100

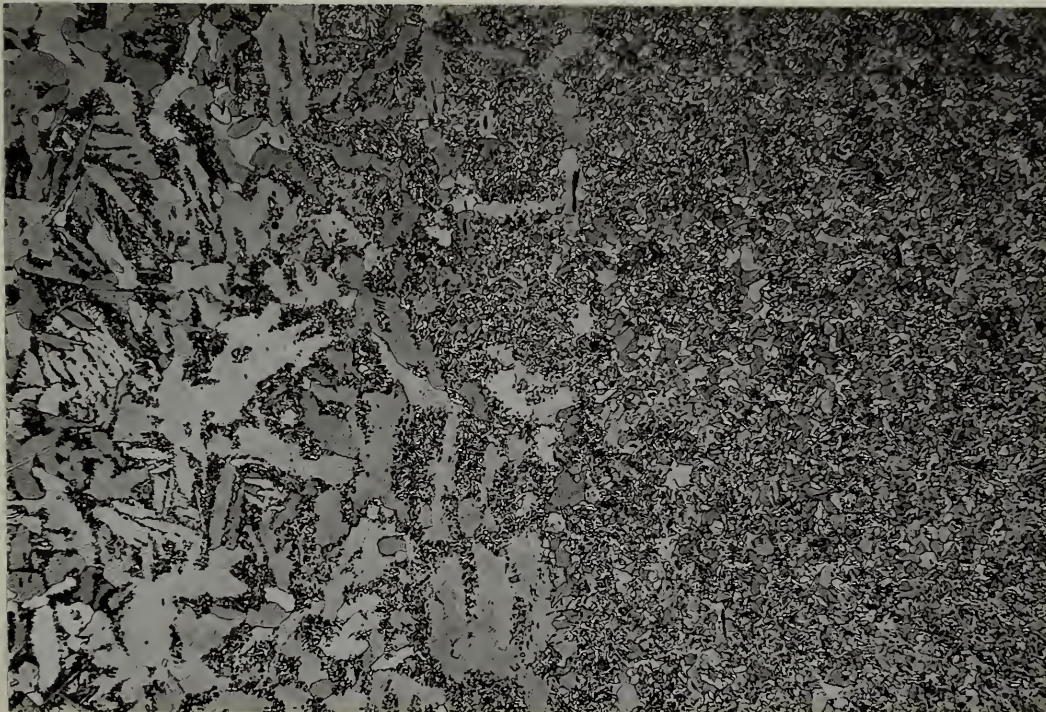
Figure 11. Transition from microstructure of vane (left) to heat affected zone (right). 1% Nital etch. X 100
